# Stability and consolidation of an ashlar barrel vault with great deformations: the church of Guimarei

S. Huerta, G. López

## Abstract

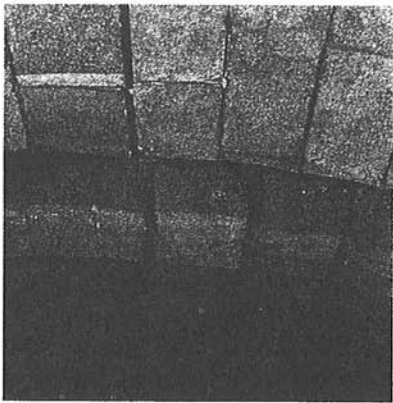
In Guimarei the cracking was due to a leaning outwards of the abutment system (walls plus counterforts) of the nave. The vault adapted itself with a "classical" pattern: a crack in the crown, directed inward, and two cracks in the haunches, directed outwards (see Figs. 2 and 6).

Figure 2: Vault cracking

However, the safety factor of 1.4 in relation to new movements, appears to be a little low. It seemed prudent, then, to recommend measures that will stabilize the geometry. Therefore it was suggested to add steel ties at approximately two thirds of the vault's height, below the cracks. The analysis of the presbytery arch yielded similar values and it was also recommended to add a steel tie, this time embedded in the masonry above the keystone.

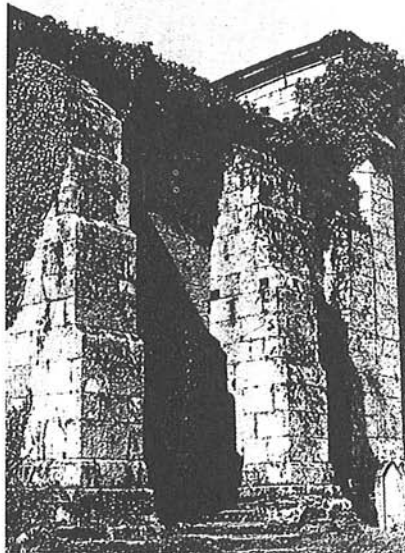
and other four small, **A**, at the corners, were added after the completion of the church (see Fig. 1). Effectively, the horizontal stone courses present an evident discontinuity both in counterforts **A** and **B** (see Fig. 3); besides, the stones of the great buttresses in contact with the wall are not square, but present a slanted face just to fit with the wall's inclination. Moreover, the stone courses of the four great counterforts are perfectly horizontal. The conclusion is that counterforts **A** and **B** were added as a mean of consolidation after the lateral walls were already out of plumb.

Figure 3: Added counterforts

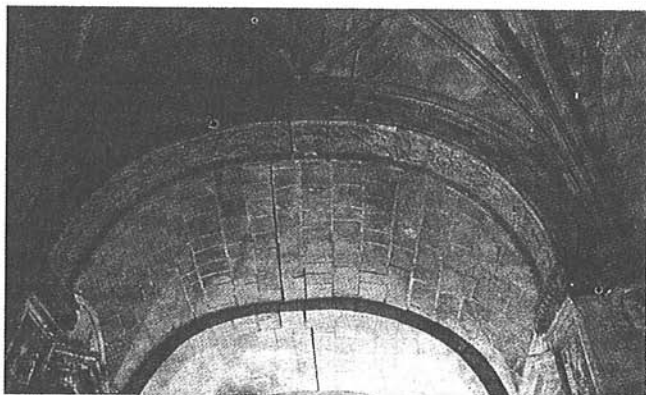
Figure 5

The presbytery wall, connected to the vault, tried to impede the movement and, not being able to resist the thrust, leaned also a little; the presbytery arch shows the corresponding cracking (the neighbouring zone of the ribbed vault was also slightly affected, see Fig. 5). In what follows we will concentrate only in the nave; in the original report a similar study was made also for the presbytery wall.

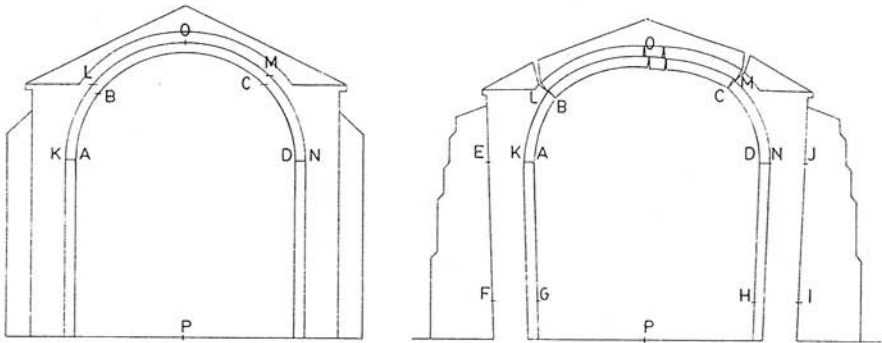
As said before, all the damages are concentrated in the nave and in the presbytery arch, and are a consequence of the leaning of the original walls and counterforts. In Fig. 8 are represented both the original (counterforts are hypothetical) and the actual distorted geometry. Table 1 summarized the measurements made to obtain the inclination of the walls. The values of Table 2 have been calculated from Table 1 supposing rigid body movements around the hinges. Some of them were checked and showed a good agreement with the actual state.

Figure 8: Original and actual deformed state (letters refer to the Tables)

It should be noted that the inclination of the walls is different inside and outside (greater). This difference of inclination have produced a separation of both faces (internal and external) of the wall, which afterwards moved independently.

When the new counterforts were added, the deformation remained. The inside inclination governs the vault deformation. This has been verified calculating the crack width in the crown (57 mm) and comparing this value with the actual width (55 mm).

The different leaning of internal and external facing of the wall suggests a crack in the wall's core; it was also recommended to make some stitching and grouting to consolidate the walls of the nave.

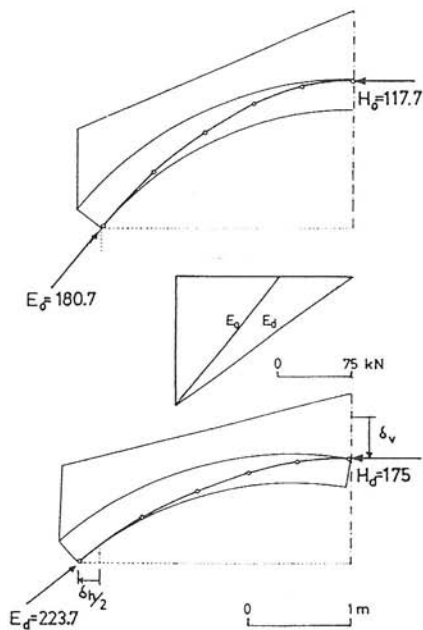
Figure 10 summarizes the result of the calculations. Due to an increase of span at the level of the hinges of 36 cm, the crown of the vault has sagged 32 cm. Note the notable the change of direction and the increase of the thrust at the inferior hinges.

Figure 10: Thrust line in the vault: (a) undeformed geometry; (b) actual geometry

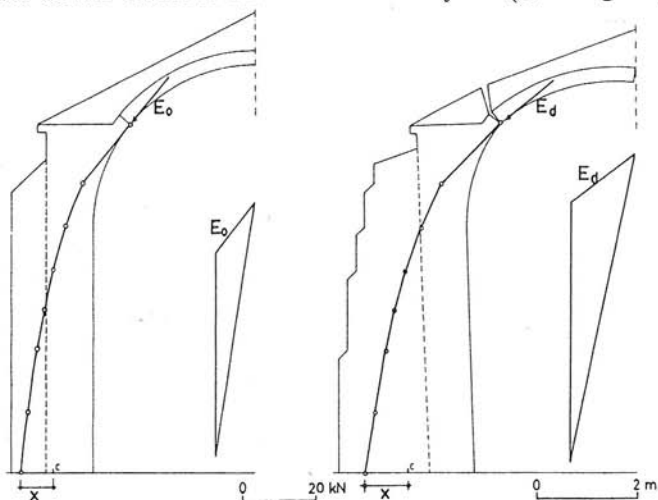
The stability in the lowest joint of the buttress was determined. The position of the thrust in this joint will give a measure of the safety of the buttress system. As before, we have made two analysis: one for the undistorted original geometry with hypothetical "gothic" counterforts; the other for the actual distorted geometry. Figure 11 summarizes the results. The geometrical factor of safety results of dividing the total width of the joint with two times the distance of the thrust to the middle of the joint ( $x$ , in Fig. 11).<sup>7</sup>

Figure 11: Stability of the abutment system: (a) undeformed geometry; (b) actual geometry

The safety factors are 1.2 for the "original" geometry and 1.58 for the actual geometry. It is evident that in the first case the stability was precarious and that a progressive inclination of the abutment system was likely to occur (indeed, that is precisely what happened).

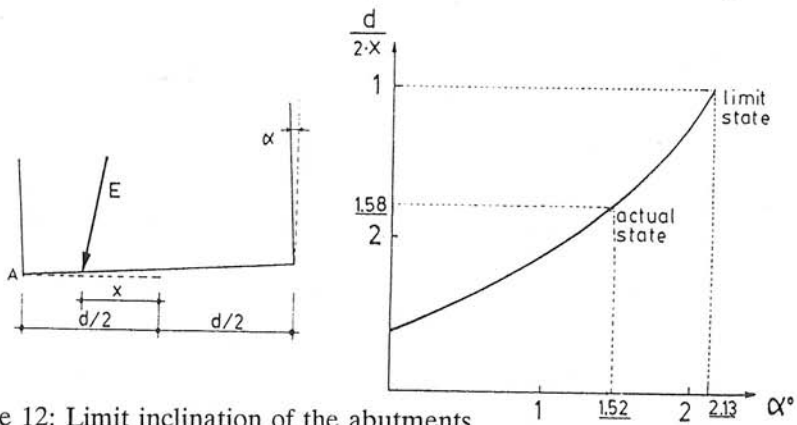
In Fig. 12 we have plotted the relative position of the thrust in the joint (the parameter  $d/2x$  is precisely the geometrical factor of safety) against a growing inclination of the buttress,  $\alpha$ . Supposing that sliding is impossible and that the deformation is fairly symmetrical, the only unknown is the centre of rotation. We have tried both extremes of the joint and the worst situation was the centre of rotation located at the outer border (A) of the joint. (In a more detailed study intermediate points should also be checked.)

Figure 12: Limit inclination of the abutments

the safety: we obtain a factor of 1.40, 15% lower than Heyman's geometrical factor.
