# Stability and consolidation of an ashlar barrel vault with great deformations: the church of Guimarei

S. Huerta, G. López

## Abstract

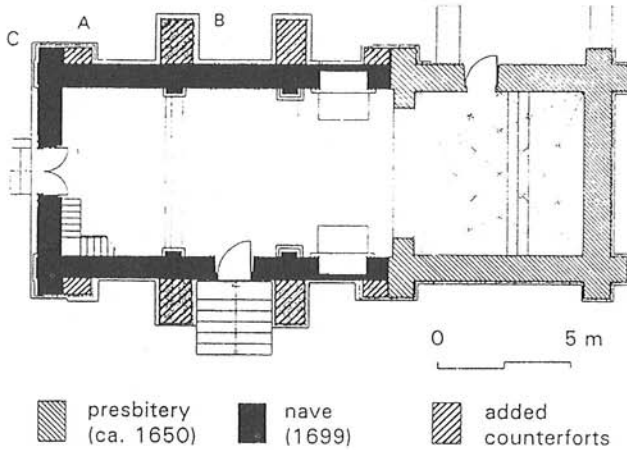
Figure 1: Plan of the church of Guimarei

From inspection of the external ashlar facing it could be deduced that the four great counterforts, **B**, that support the central zone of the nave,

and other four small, **A**, at the corners, were added after the completion of the church (see Fig. 1). Effectively, the horizontal stone courses present an evident discontinuity both in counterforts **A** and **B** (see Fig. 3); besides, the stones of the great buttresses in contact with the wall are not square, but present a slanted face just to fit with the wall's inclination. Moreover, the stone courses of the four great counterforts are perfectly horizontal. The conclusion is that counterforts **A** and **B** were added as a mean of consolidation after the lateral walls were already out of plumb.

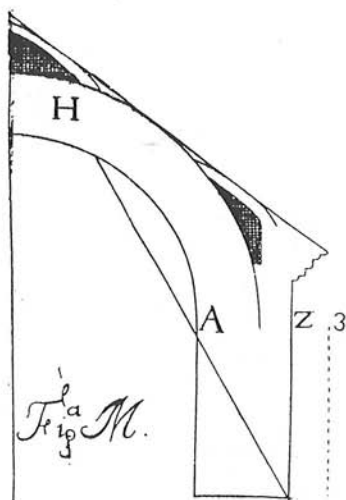
Figure 4: Comparison of structural rules: gothic" ( $AZ = \text{span}/4$ ); "renaissance" ( $A3 = \text{span}/3$ )

There exists contemporary evidence. Juan García de Berruguilla, a spanish eighteenth-century builder, commented in his treatise *On the true practice of geometry*<sup>4</sup> the different rules for vault abutments and stressed the contradiction between some of them. In Fig. 4 the so-called Blondel's rule, which is gothic and intended for gothic vaults, is compared with the renaissance rule of the third of the span.<sup>5</sup> The difference is evident and he concludes that this has led to many collapses: "Both rules are very old and the contradiction between them is before the eyes. And this is the origin of so many ruins that we are experiencing in the whole World...".<sup>6</sup> The drawing is explicit and, in fact, a barrel vault needs 30-40% more buttressing than a ribbed vault.
